INDOOR AIR QUALITY ASSESSMENT

**Sumner Avenue Elementary School
45 Sumner Avenue
Springfield, Massachusetts**

Prepared by:
Massachusetts Department of Public Health
Bureau of Environmental Health Assessment
December 2002

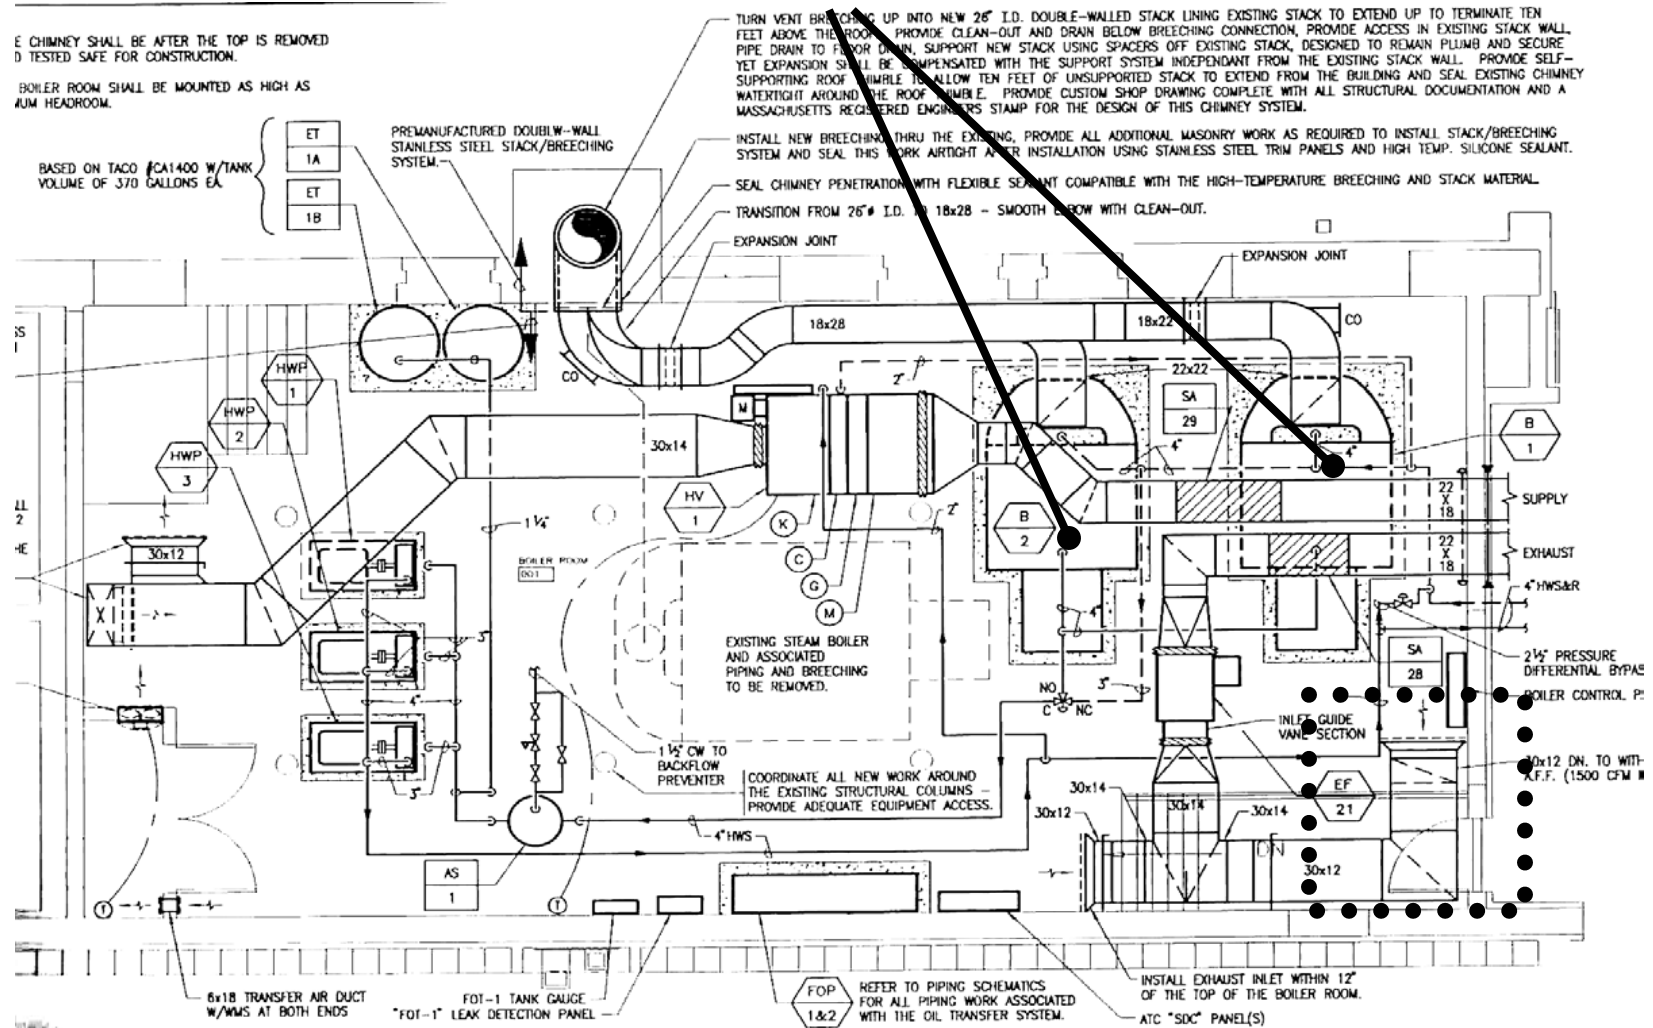
Several conditions exist in the boiler room that may also provide for products of combustion to enter this room. The configuration of the ventilation system in the boiler room may be problematic. A return air vent is located near the front of the boilers (HMFH; 1997; see Blueprint 4). In this configuration, the return vent has the potential to draw air and related pollutants from the boilers when the power vent is deactivated. In order for boilers to combust fuel a sufficient supply of oxygen is necessary. The return vent location may have the following negative effects if the draw of air is greater than the boiler when the power vent is deactivated:

The purpose of a return air vent in the boiler room is unclear. In this configuration, the return vent should not operate if the boiler is operating. A collection of soot was noticed beneath a horizontal section of boiler exhaust vent duct. An examination found a hole at the bottom of each duct filled with tattered fiberglass insulation. It appears that as the boiler power vents operate, products of combustion are forced into the duct and are exiting the duct through this hole. Exhaust vent pipes should be continuous to prevent this contingency. In addition, the configuration of the exhaust vent ducts tends to restrict the exhaust of air from the boilers. The duct to the chimney connected to the gas water heater is horizontal, approximately 40 feet in length and has an estimated 540° in turns of duct. In general, exhaust ducts should minimize the numbers of horizontal pipes and turns. Increasing length and turns in exhaust ductwork can decrease the efficiency of products of combustion to the chimney. In addition, several extra lengths of duct exist off the main line of exhaust airflow in the ducts. These extra lengths of exhaust vent create dead spaces where products of combustion can accumulate. Under these conditions, products of combustion can pool in the ducts. Water vapor mixing with other products of combustion can create corrosive materials that can degrade the metal of the ductwork. Products of combustion then may enter into occupied areas through spaces beneath the boiler room door as well as other holes that lead to occupied spaces. Operating equipment

Return Vent in Close Proximity to Boilers in Boiler Room (within Dotted Box)

6. Examine the purpose of the return air vent in the boiler room. If its purpose cannot be identified, consideration should be given to sealing this vent to prevent the draw of products of combustion from the boiler.
